**Aviation Life Support Equipment Retrieval Program:  
Report of Aircraft Mishap 95-4, Involving the  
HGU-56/P Army Aviation Helmet**

**March 1996**

**U.S. Army Aeromedical Research Laboratory  
Fort Rucker, Alabama 36362-0577**

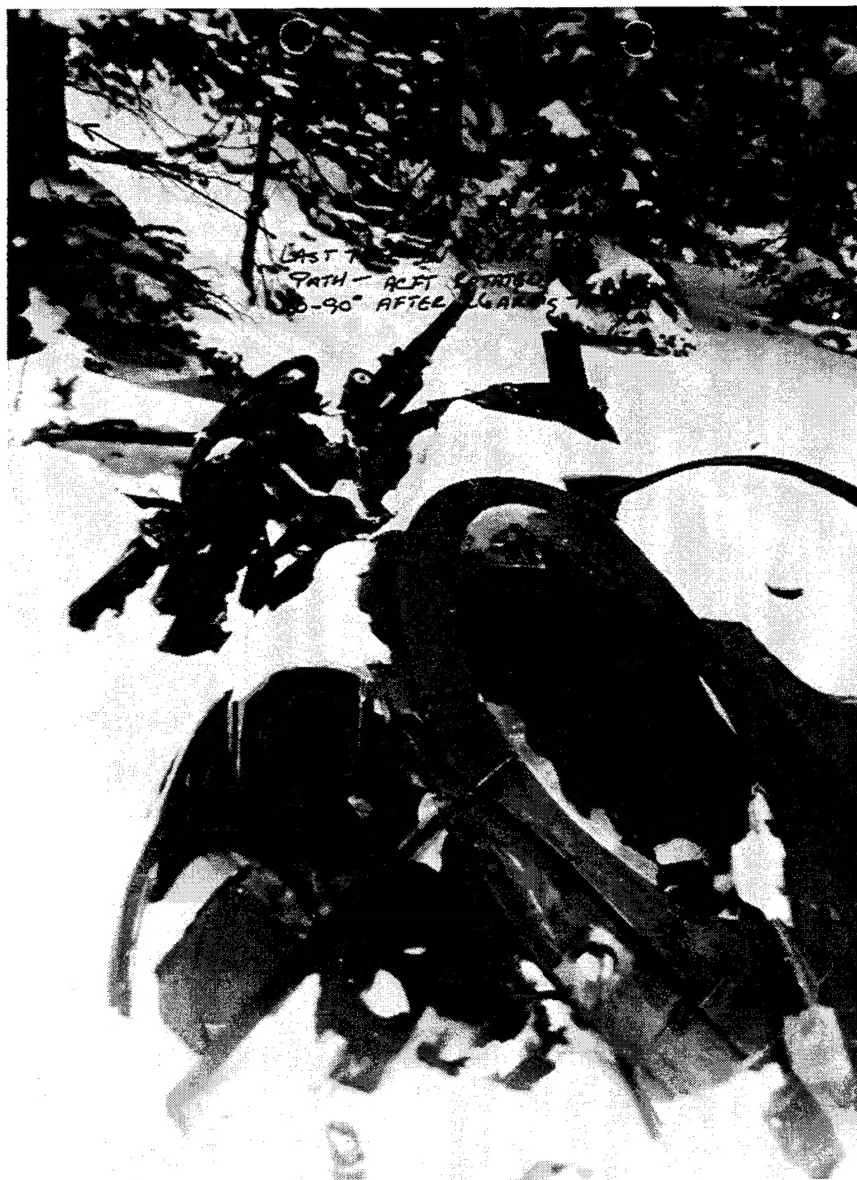
The aircraft first came in contact with the trees at a forward speed of approximately 12 knots, in a right 30-degree roll, with the nose pitched down 10 degrees, descending at approximately 500 feet/minute. The flight path and impact angle was 57 degrees down. The aircraft sustained major damage to its right side as it descended through the trees impacting the ground at 9 Gs. The aircraft yawed 75 degrees from the initial impact heading and came to rest on its right side. Because the livable space was not compromised and the crash forces were within human tolerance, the crash was deemed survivable.

Figure 1. The AH-6J at the crash site.

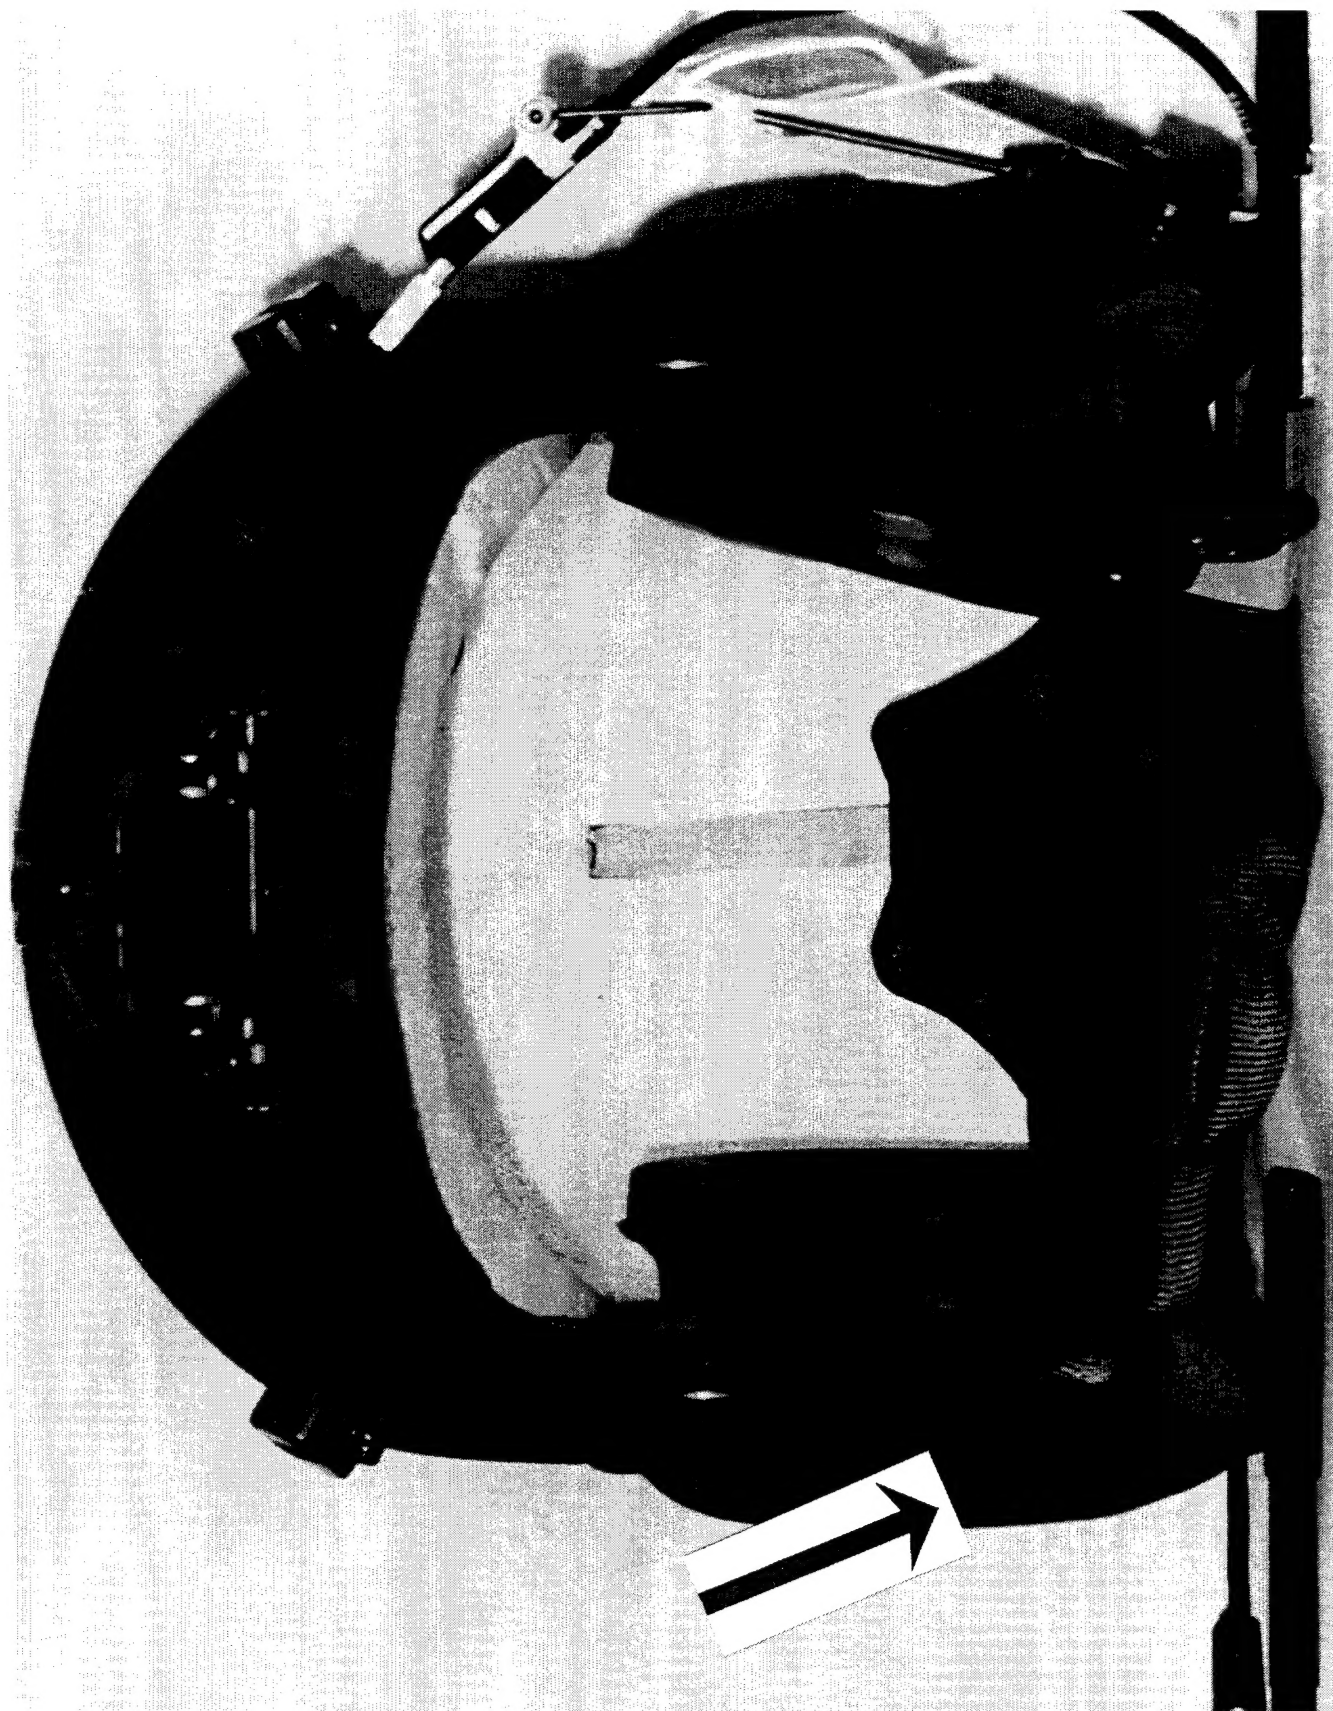
Both occupants were wearing the new HGU-56/P Army aviation helmet. The copilot's helmet was undamaged in the mishap. The ALSERP team analyzed the damaged HGU-56/P worn by the pilot in command in accordance with USAARL Policy No. 95-55 (1985). This impact, from an undetermined type of surface, caused a 3½-inch complete shell fracture on the eardome from front to rear and a 1-inch horizontal hairline fracture on the same eardome from rear to front (Figs. 2- 3). A complete tear down and inspection revealed no other damage. The energy-attenuating earcup did not exhibit markings indicative of deformation. Therefore, it is not likely that the earcup was exposed to significant impact forces.

Figure 2. The damaged HGU-56/P Army aviation helmet.

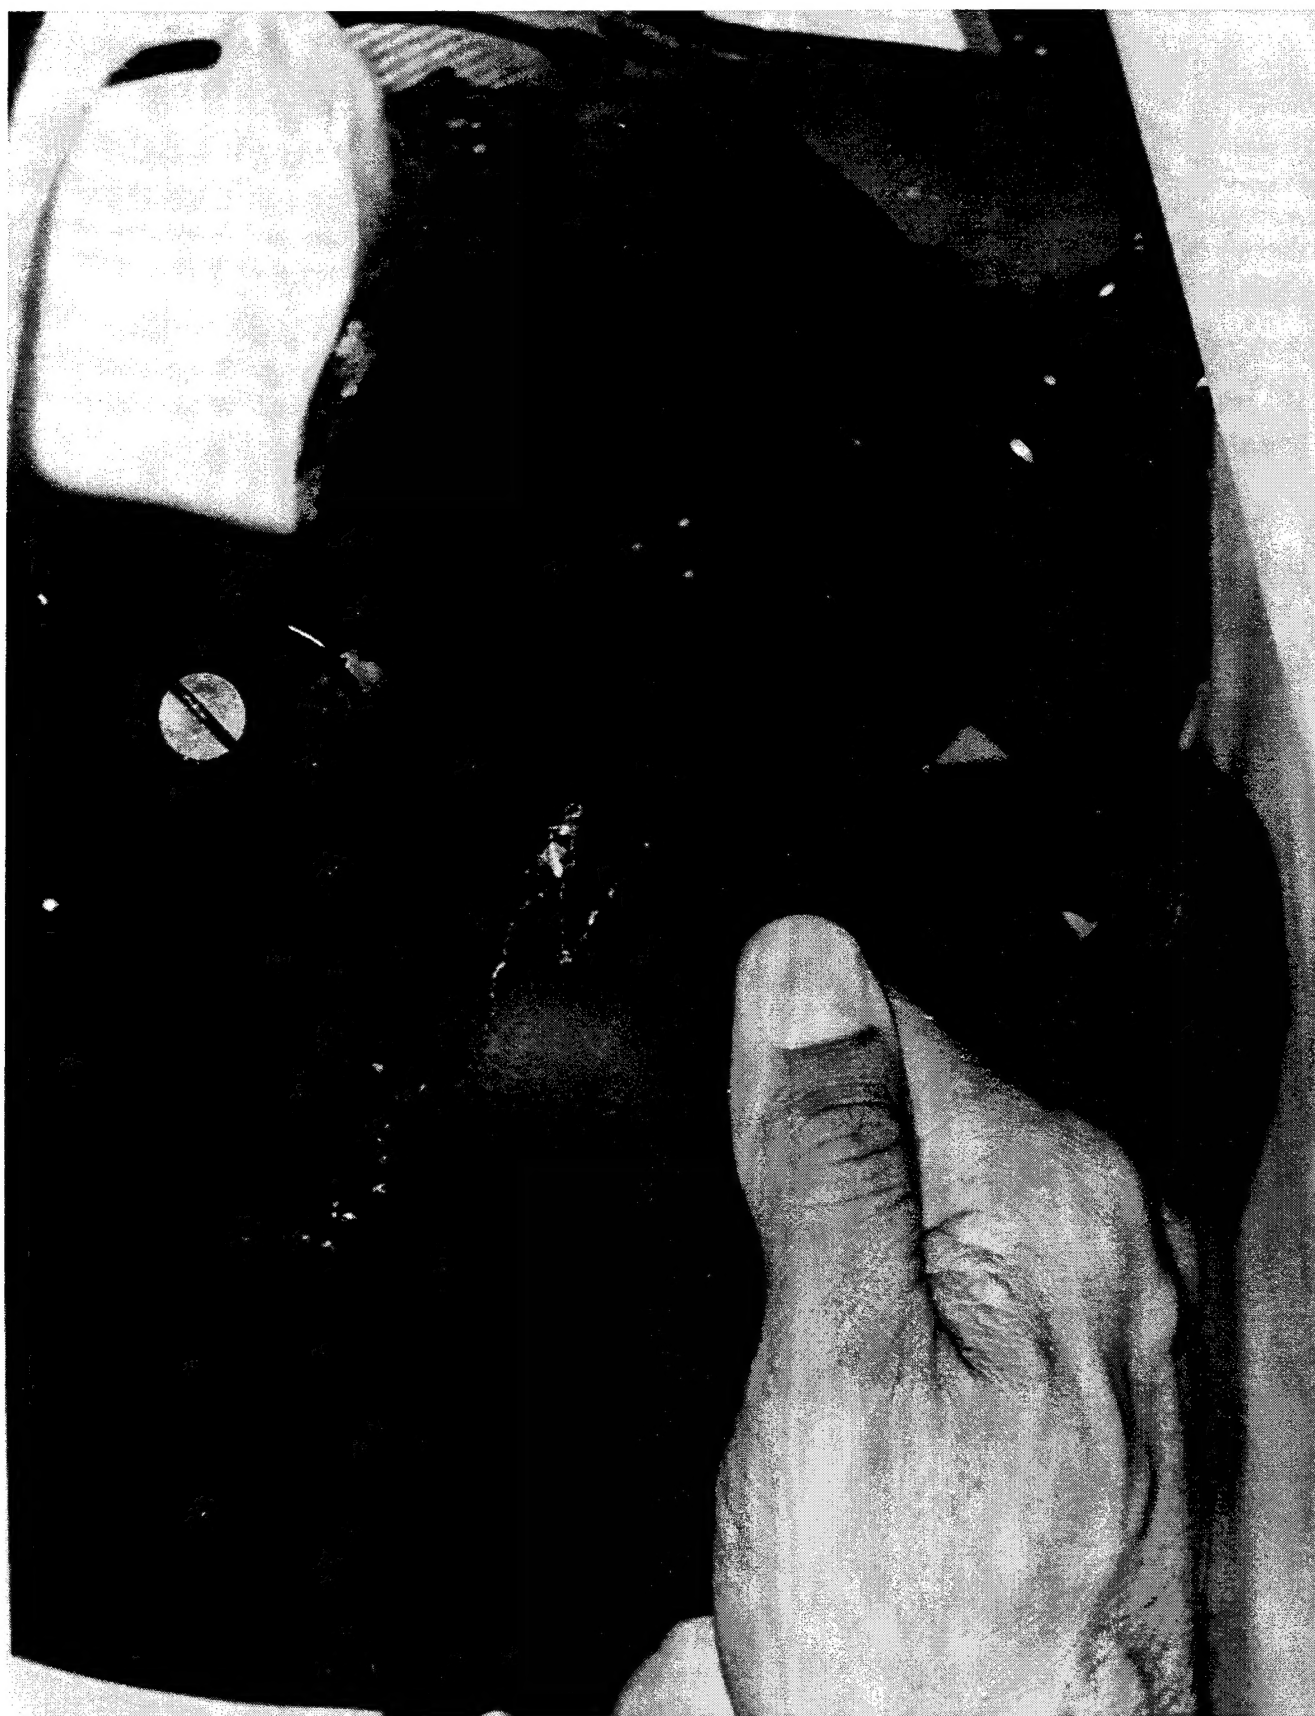
The first HGU-56/P recovered from a mishap provided adequate protection to the crewmember. The helmet was retained on the wearer's head indicating proper fit and function of the retention assembly. Although it was rendered unserviceable in the mishap from a sharp blow to the bottom right eardome, the impact forces were not transmitted to the pilot's head. The facial laceration and contusion to the pilot's chin are not attributable to the HGU-56/P. The energy-attenuating earcups did not appear to have been exposed to significant impact. The crash forces encountered in this mishap did not cause the protective capabilities of this helmet to be fully challenged.

Figure 3. The impact to the right eardome was sufficient to completely fracture the helmet.
